Memorandum

To: Mr. Paul Dunlap, California Department of Water Resources
From: Oroville Dam Spillway Incident Independent Forensic Team
Date: September 5, 2017
Re: Interim Status Memorandum

Introduction – The Independent Forensic Team (IFT)¹ is conducting a thorough review of available information to develop findings and opinions on the chain of conditions, actions, and inactions that in February 2017 caused the damage to the service spillway² and emergency spillway at Oroville Dam, and why opportunities for intervention in the chain of conditions, actions, and inactions were not realized.

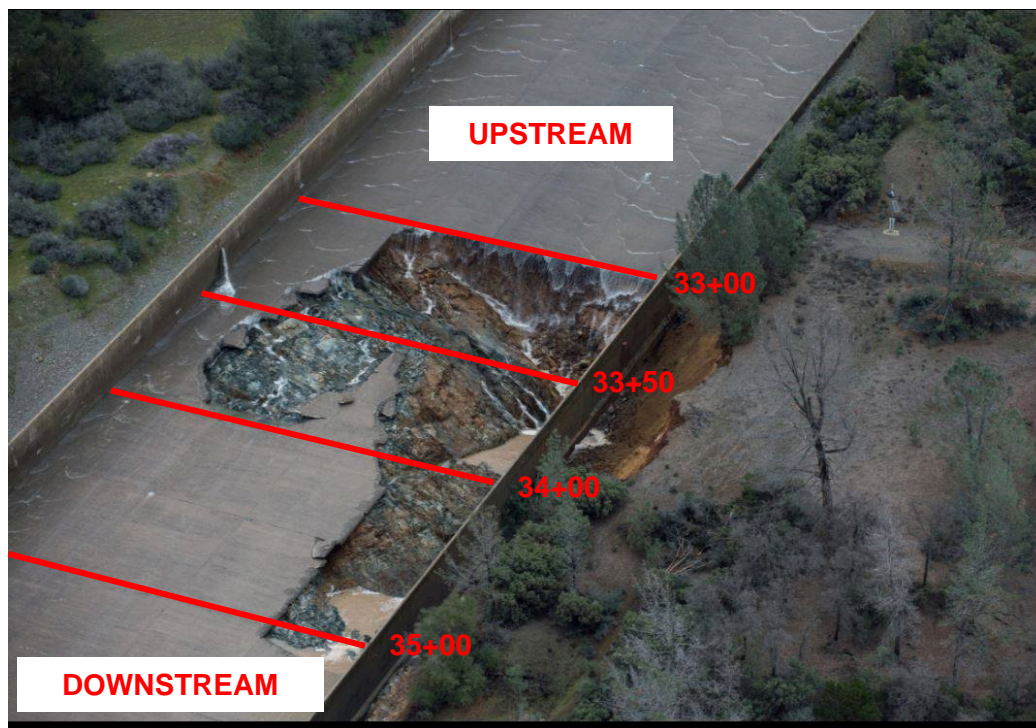
Update on Initiating Event of Service Spillway Chute Failure – The IFT believes that the service spillway chute failure most likely initiated by the uplift and removal of a section of the slab in the chute downstream of Station 33+50 at shortly after 10:00 am on February 7. Once the initial section of the chute slab was removed, the underlying moderately to highly weathered rock and soil-like material beneath the slab in this location was directly exposed to high-velocity spillway flow. The high-velocity flow rapidly eroded the foundation materials at this location, removed additional chute slab sections in both upstream and downstream directions, and quickly created the erosion hole that was observed by 12:30 pm on February 7, as flows diminished following spillway gate closure – see photo below. These findings are based on eyewitness accounts, and photo and video records.

Since all physical evidence at the point where the failure initiated was destroyed, it will never be possible to confirm exactly where the initiating event occurred. Others have suggested that the uplift initiated at Station 33+00 (see photo above). However, the IFT has concluded that, although there may have been water injection along the Station 33+00 joint, that was almost certainly not the location of the initial failure. Had the failure initiated along that joint, the concrete keys at the joint would have been damaged, and this was not observed when the spillway gates were closed, and the eroded hole was inspected on February 8 by a climb team engaged by DWR. The slab section downstream of the joint at that location could not have lifted without shearing the concrete key in the upstream slab section, and this condition was not observed in the photos and videos taken by the climb team, which were carefully reviewed by the IFT.
